EXTENDED LIFE COOLANT TESTING

**INTERIM REPORT
TFLRF No. 478**

1. REPORT DATE (DD-MM-YYYY) 06-06-2016		2. REPORT TYPE Interim Report		3. DATES COVERED (From - To) June 2014 – June 2016	
4. TITLE AND SUBTITLE Extended Life Coolant Testing Simulated Service Corrosion Testing of Traditional and Extended Life Coolants				5a. CONTRACT NUMBER W56HZV-09-C-0100	
				5b. GRANT NUMBER	
				5c. PROGRAM ELEMENT NUMBER

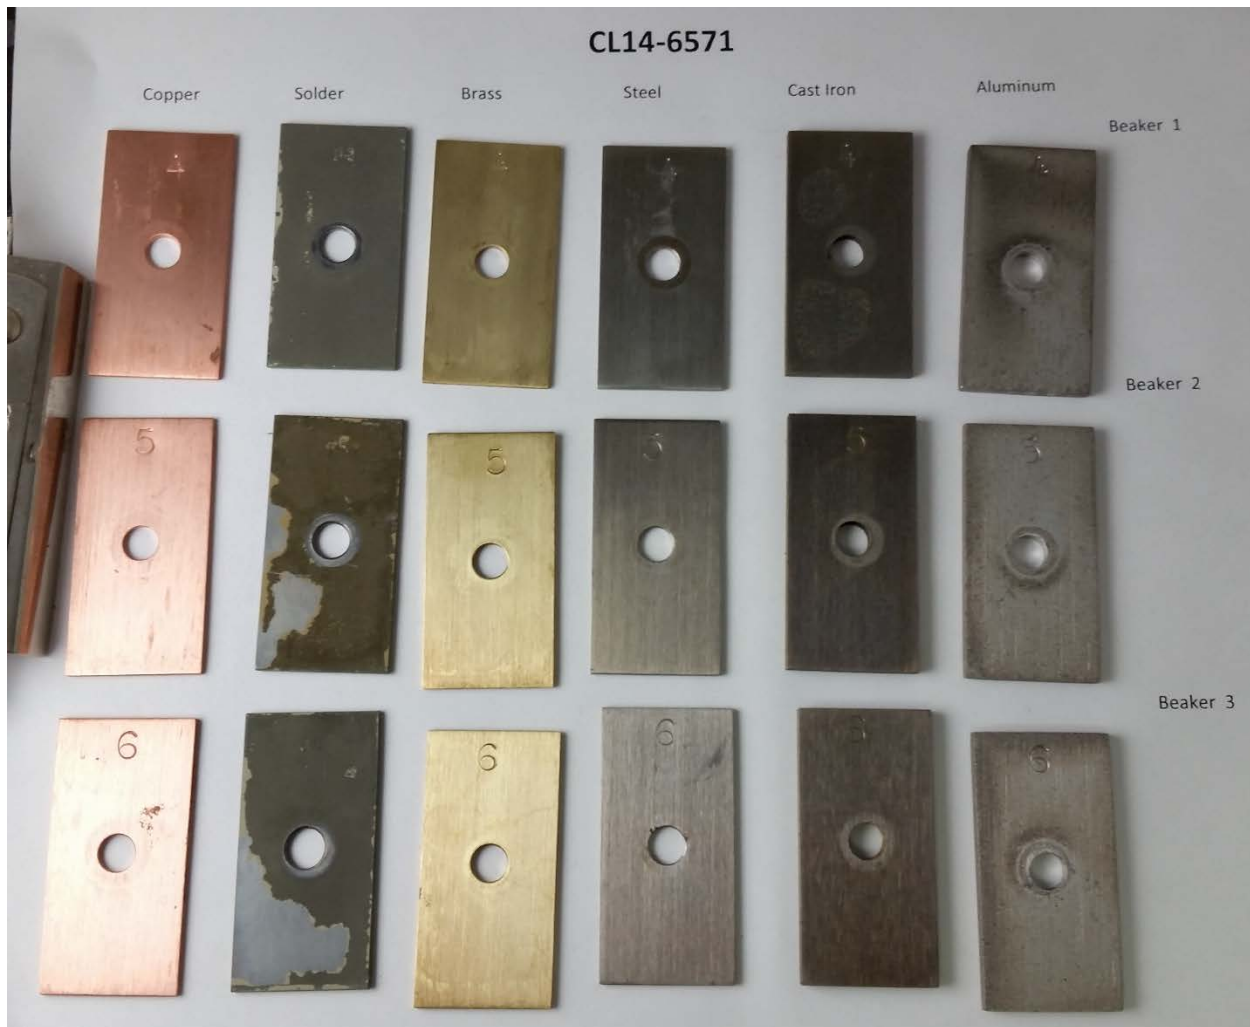
Figure 2. ASTM D1384 Coupons for Test CL14-6571 Extended Life Coolant #2

The solder coupons in Figure 2 showed an average weight gain of 176.3 grams. The cleaning process for the solder involved brushing the coupons with a soft bristle brush to remove any loose deposits. Then they were immersed for 5 minutes in a 1% solution of glacial acetic acid. The coupons were then rinsed in deionized water and brushed again. This cleaning procedure, which is outlined in the ASTM D1384 method, removed some of the salt crust that formed, but not all.

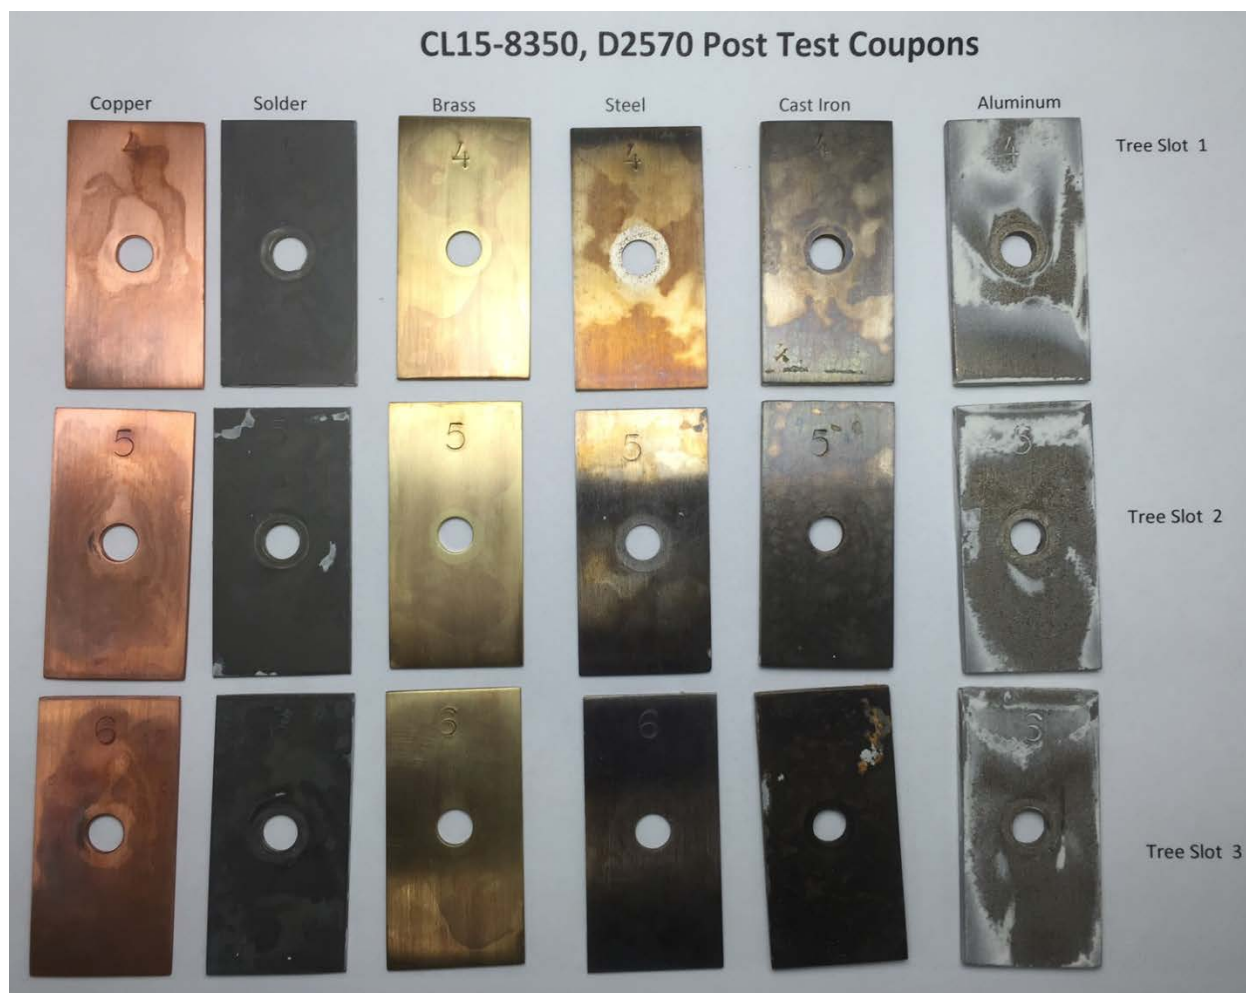
Figure 6. ASTM D2570 Coupons for Test CL15-8350, 5% EG & 45% ELC1

which was a mixture of 5% ethylene glycol, 45% ELC1, and 50% water, there was significant material accumulation on the aluminum coupons as seen in Figure 5 and Figure 6.

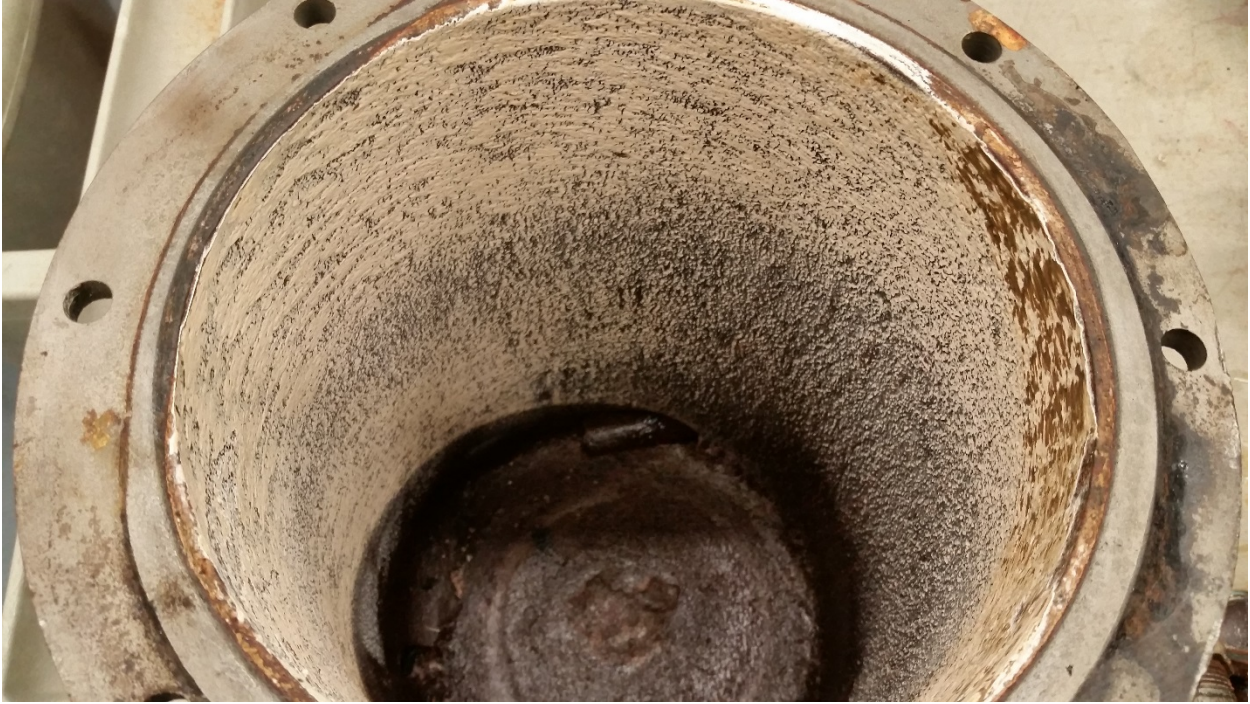
Figure 7. Cast iron vessel after test that had multiple pump failures

Although no samples were analyzed, pictures were taken of the heavy deposits inside the cast iron vessel and of the 'grease' that was collected from the system, Figure 7 and Figure 8.

It is possible that there was some chemical reactions occurring between the corrosive water and the grease that was leaked into the system. In terms of corrosion, the third test still passed by not exceeding any of the mass loss limits, but since water pump failures can and do occur in the field, it may be of interest to further investigate the interaction of coolant mixtures and bearing greases typically found in the coolant pumps. This could ensure that the coolant system would not clog up and still be serviceable after replacement of a failed pump.

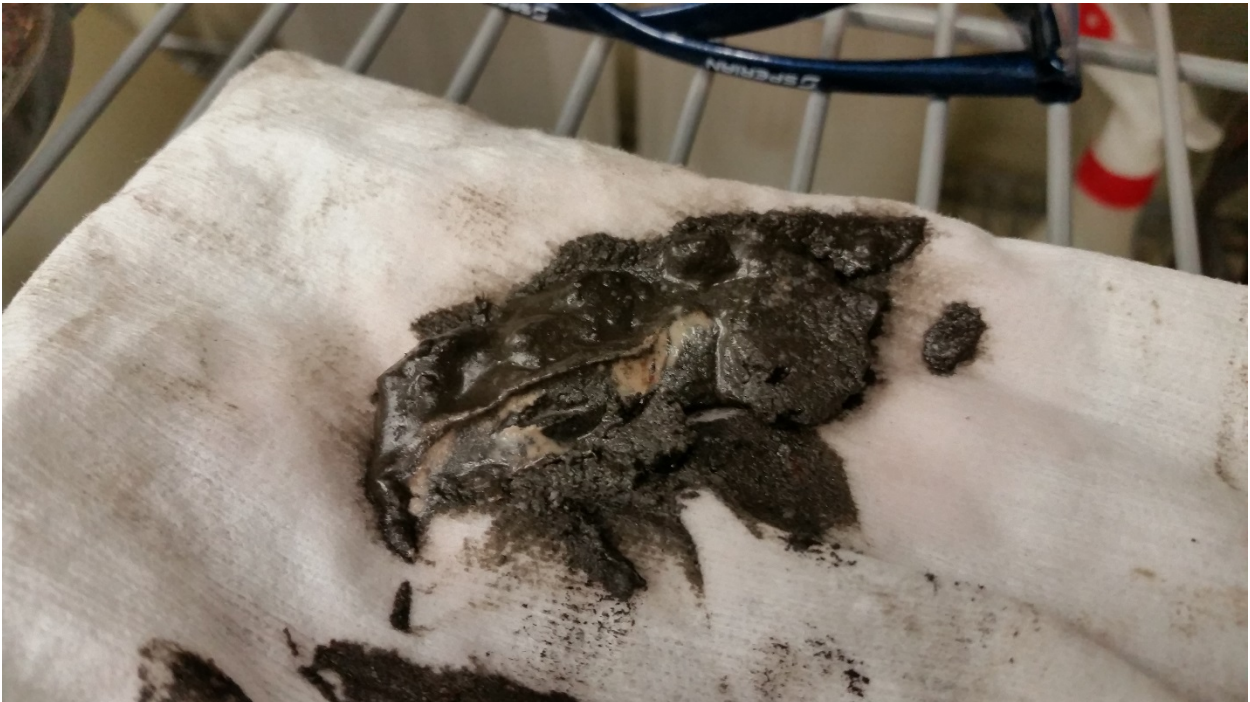
Figure 8. 'Grease' found at bottom of cast iron vessel
